ADDENDUM NO. 1

**PAVEMENT REHABILITATION AND SAFETY IMPROVEMENTS PROJECTS
28TH DRIVE NW – 81ST STREET NE HOUSING AREA ROADS –
TOTEM BEACH ROAD**

As requested, HWA GeoSciences Inc. (HWA) has completed a geotechnical investigation for the proposed improvements along 81st Street NE, 29th Drive NE, and 30th Drive NE on the Tulalip Indian Reservation in Snohomish County, Washington. This report presents the results of our field explorations and laboratory testing along with our recommendations pertaining to stormwater infiltration, luminaire/signal pole foundations and pavement design.

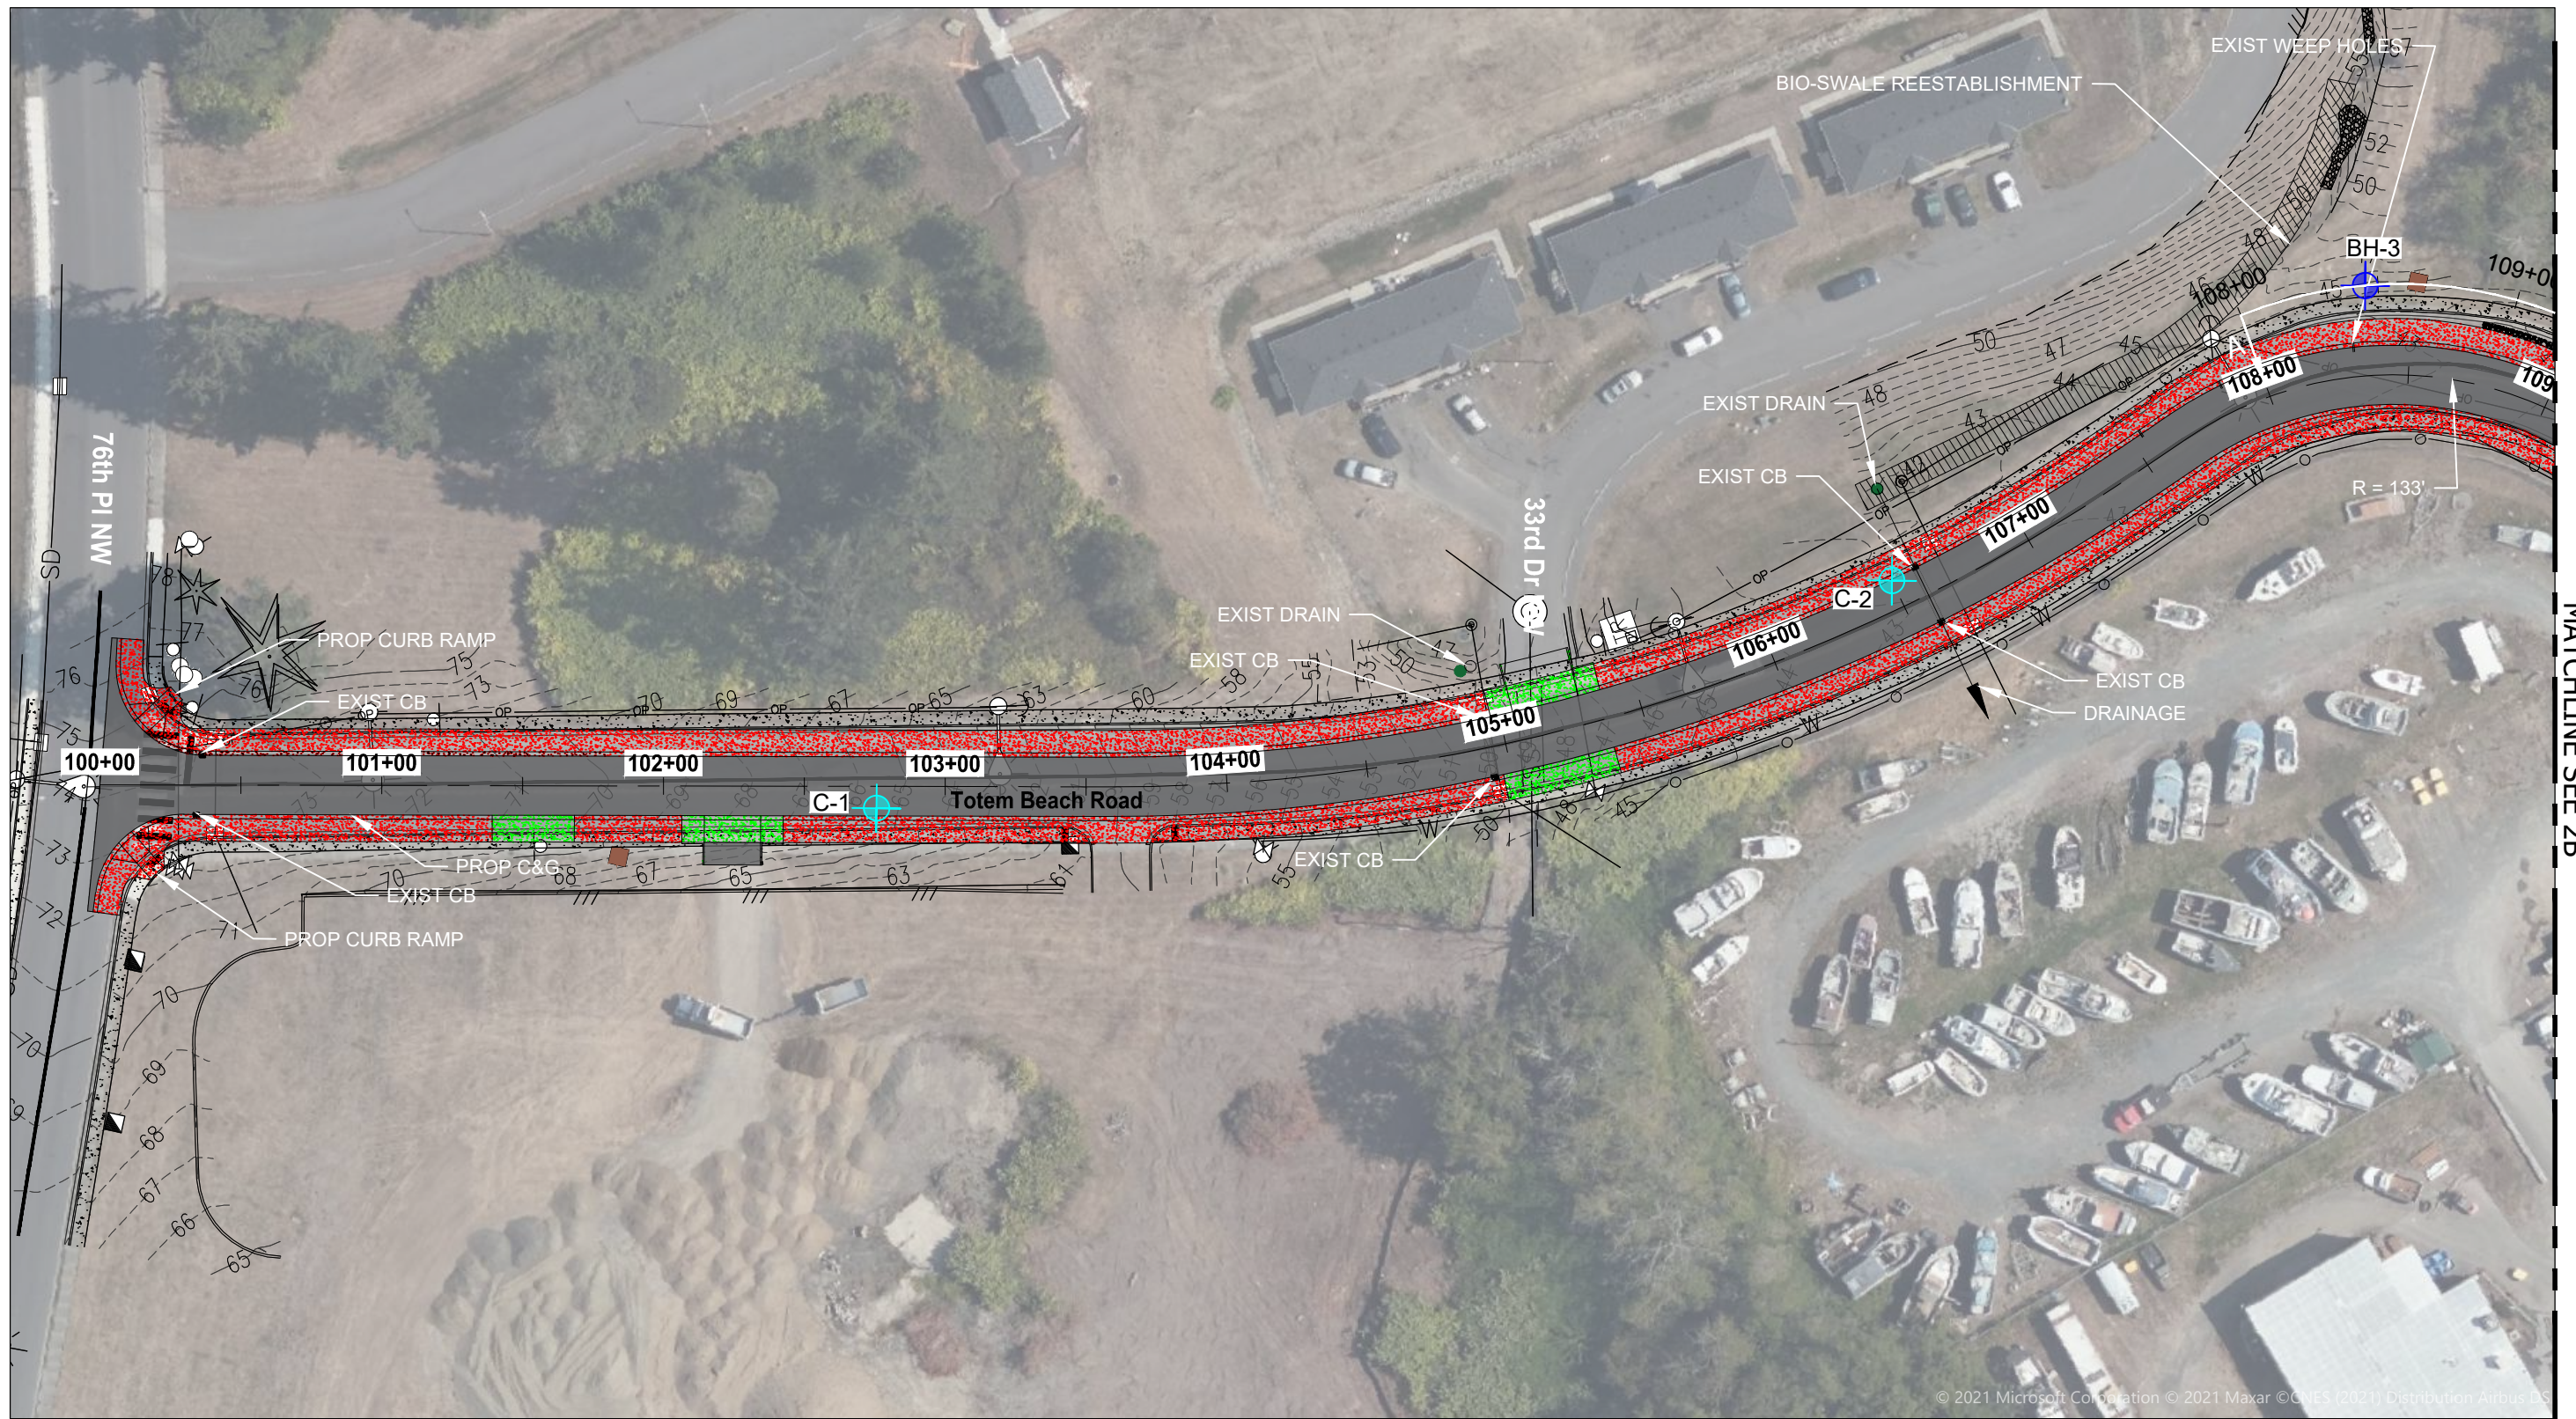
DRAWN BY: CF	FIGURE NO.: 2A
CHECK BY: SEG	PROJECT NO.: 2021-036-21

SITE &
EXPLORATION PLAN

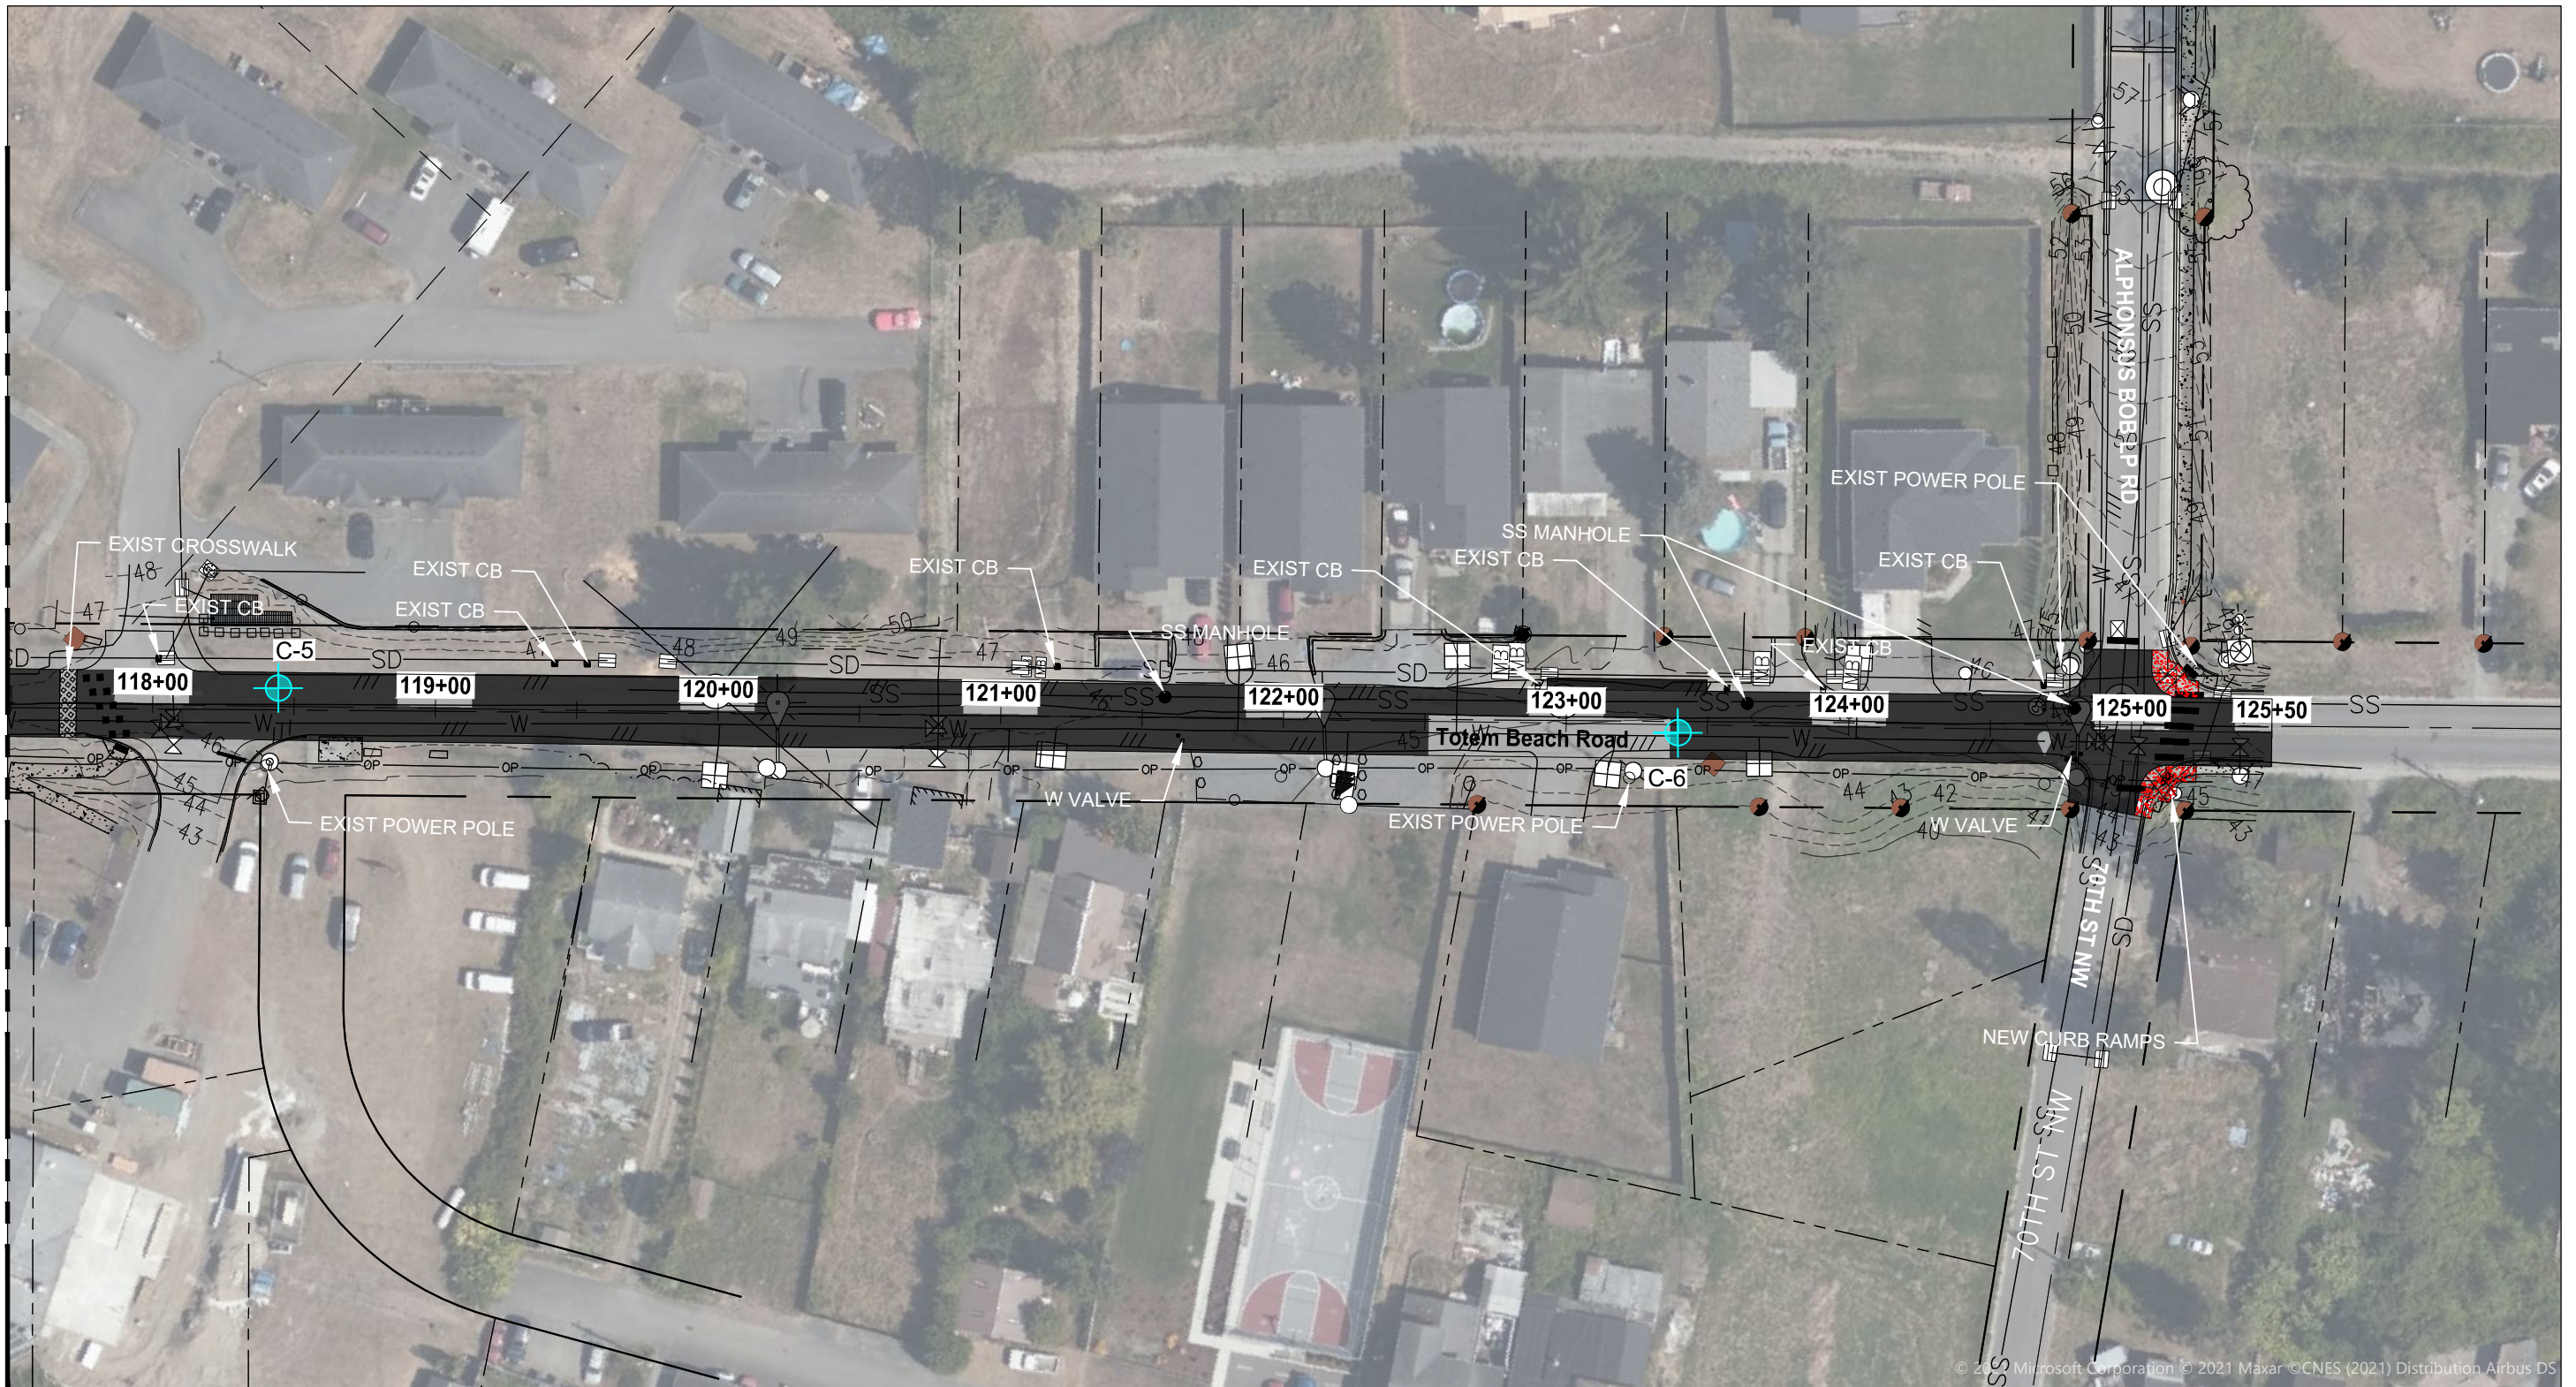
DRAWN BY: CF	FIGURE NO.: 2C
CHECK BY: SEG	PROJECT NO.: 2021-036-21

TOTEM BEACH ROAD
Scale: 1" = 60'-0"

SITE &
EXPLORATION PLAN

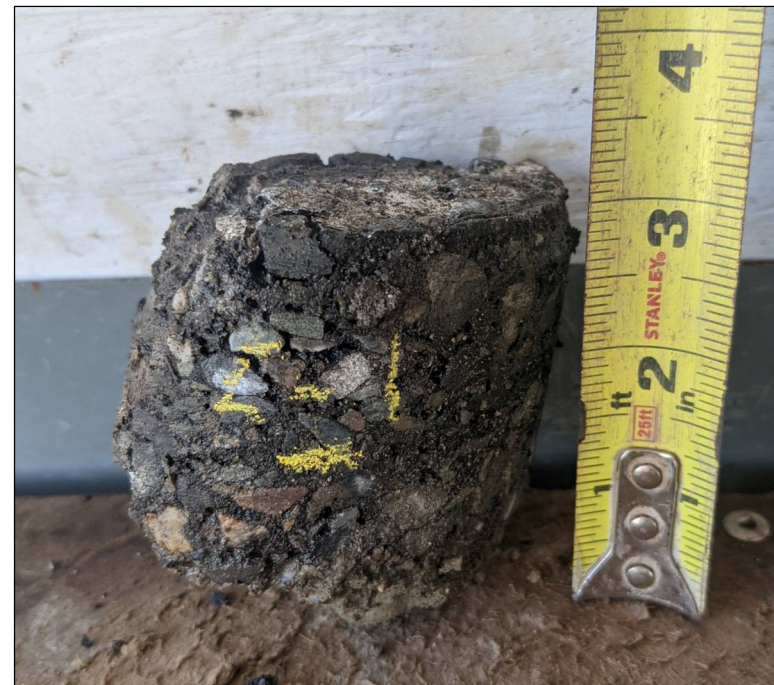
PAVEMENT CORE PHOTO

DEPTH (feet)	SYMBOL	USCS SOIL CLASS.	DESCRIPTION	SAMPLE TYPE	SAMPLE NUMBER	MOISTURE CONTENT(%)	OTHER TESTS
0			3.0-inches Hot Mix Asphalt. 2 Lifts: 1.5" x 1.5" Cored on high severity alligator cracking. Cracked through full depth. Lifts are bonded. (HMA)				
	GP		Dense, brown, sandy GRAVEL, moist. (FILL)				
	ML		Stiff, gray with brown mottling, SILT, moist. (VASHON RECESSONAL OUTWASH)				
			Becomes silty and sandy.				
3			Corehole was terminated at 2.5-feet below ground surface. No groundwater seepage was observed during the exploration.

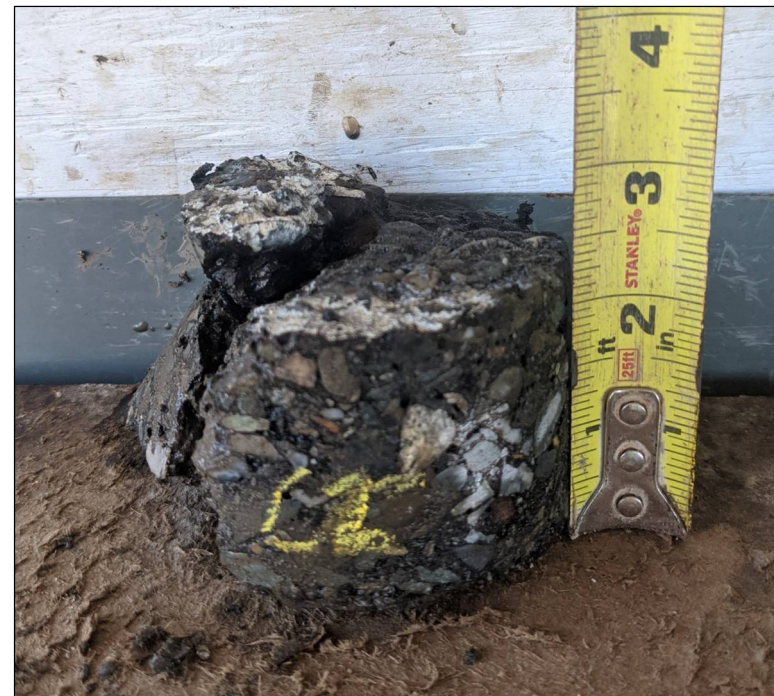
PAVEMENT CORE PHOTO

DEPTH (feet)	SYMBOL	USCS SOIL CLASS.	DESCRIPTION	SAMPLE TYPE	SAMPLE NUMBER	MOISTURE CONTENT (%)	OTHER TESTS
0			2.25-inches Hot Mix Asphalt. 2 Lifts: 1.0" x 1.25"				
	SP		Cored on high severity alligator and longitudinal cracking. Cracked through full depth. Lifts are bonded. (HMA)				
			Dense, brown, SAND, with gravel and cobbles, moist. (VASHON RECESSIONAL OUTWASH)				
3			Corehole was terminated at 1.0-feet below ground surface. No groundwater seepage was observed during the exploration.

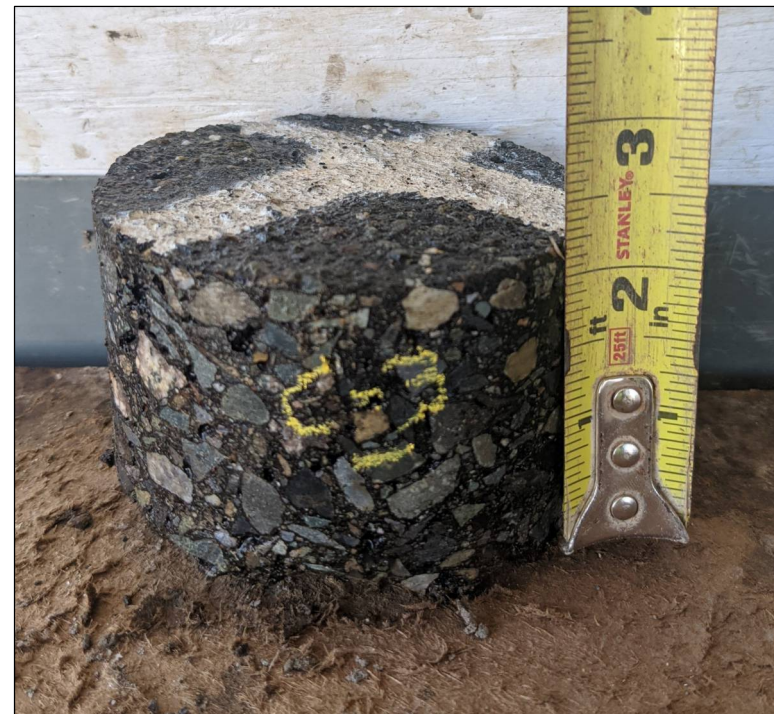
PAVEMENT CORE PHOTO

DEPTH (feet)	SYMBOL	USCS SOIL CLASS.	DESCRIPTION	SAMPLE TYPE	SAMPLE NUMBER	MOISTURE CONTENT (%)	OTHER TESTS
0			2.25-inches Hot Mix Asphalt. 2 Lifts: 1.125" x 1.125" No cracking at core location. Lifts are bonded. (HMA)				
	SP SM		Dense, brown, SAND, with silt and gravel, moist. (VASHON RECESSONAL OUTWASH)				
3			Corehole was terminated at 2.0-feet below ground surface. No groundwater seepage was observed during the exploration.

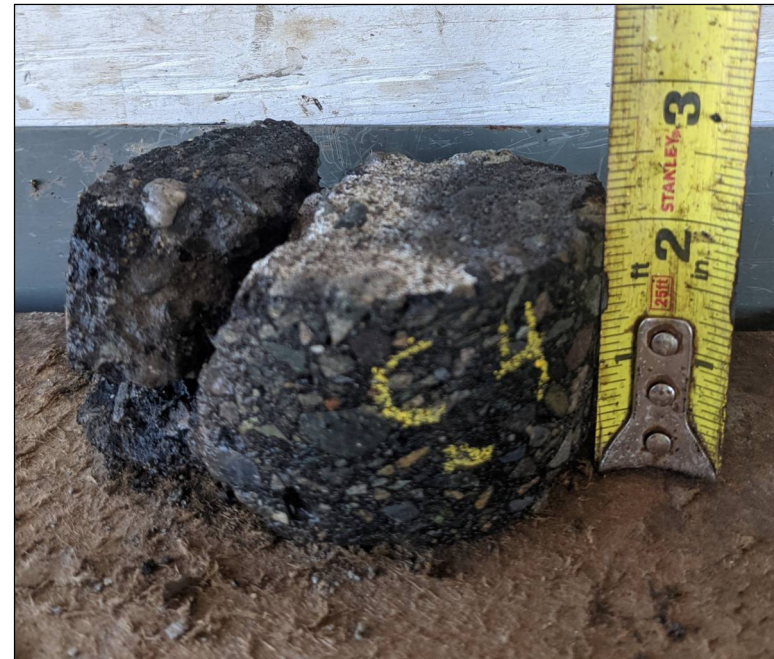
PAVEMENT CORE PHOTO

EXCAVATION COMPANY: HWA GeoSciences Inc.
 EXCAVATING EQUIPMENT: 4-inch Diameter Core Barrel
 STREET: Totem Beach Road, Westbound, 4.5' from edge of pavement

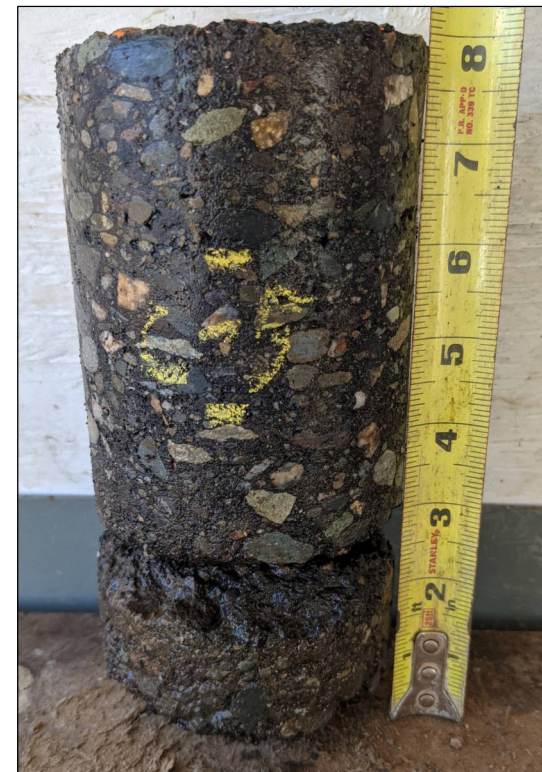
PAVEMENT CORE PHOTO

EXCAVATION COMPANY: HWA GeoSciences Inc.
 EXCAVATING EQUIPMENT: 4-inch Diameter Core Barrel
 STREET: Totem Beach Road, Eastbound, 7.6' from edge of pavement
